NATIONAL PROGRAM FOR INSPECTION OF NON-FEDERAL DAMS
GALE MEADOWS DAM (VT (U) CORPS OF ENGINEERS WALTHAM MA
NEW ENGLAND DIV MAR 80

GAIA MEADOWS DAM VT 00115

MAR 1980

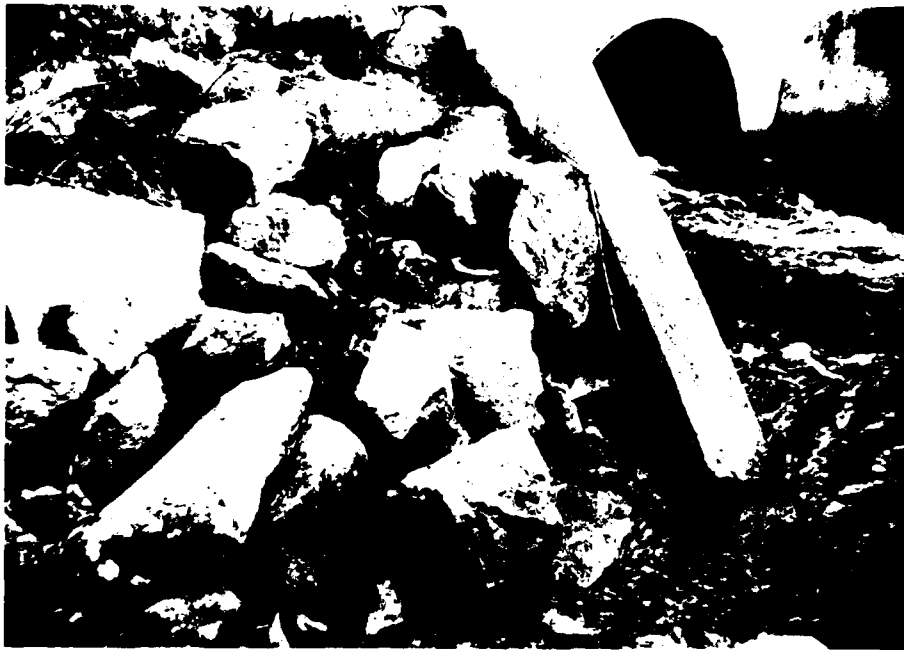
C-4A Seep at right wingwall of service spillway outlet structure.
11/19/79

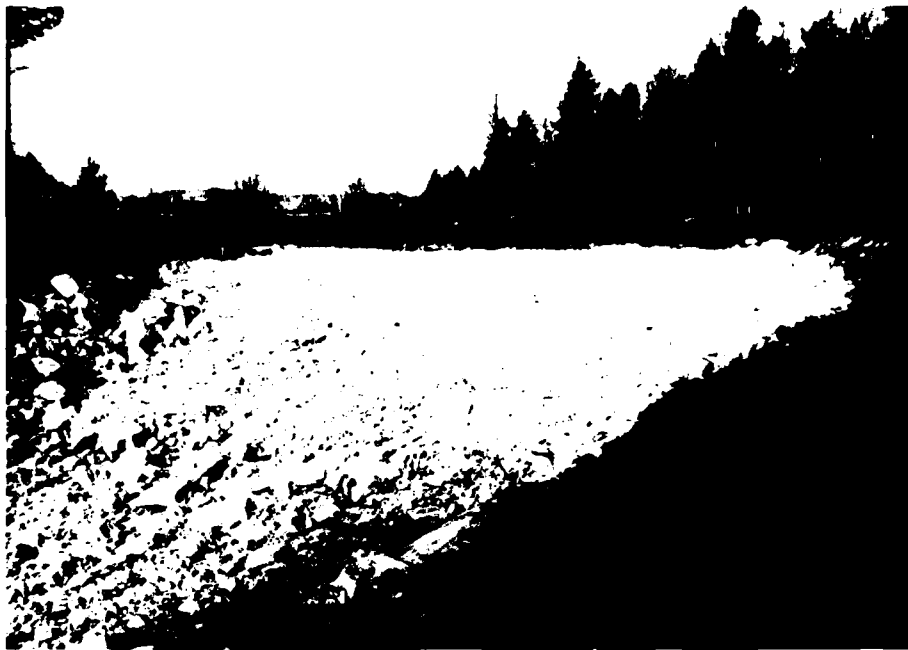
C-10A Emergency spillway discharge channel looking upstream
toward dam crest - 11/19/79
